Detail and axonometry - Connection to the historic building

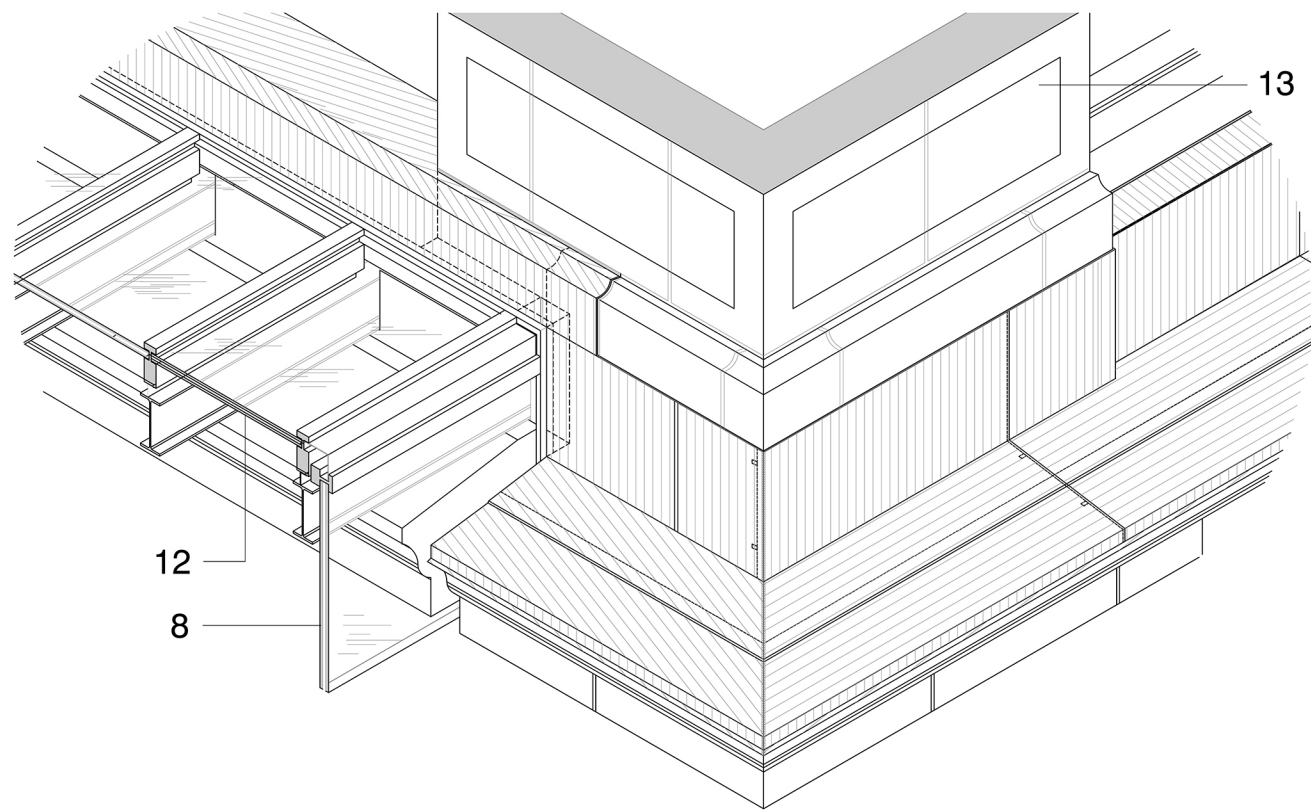
- 1 Curtain wall - steel reinforced to support solar shading baffles. Sealed glazing units with tempered glass
- 2 10mm anodized Aluminum shading baffle anchored to curtain wall brackets by stainless steel plates and countersunk bolts.

- 3 Curtain wall support - Built-up column of welded steel plates.
- 4 Corner assembly - 3mm aluminium bent sheet, cavity filled with insulation.
- 5 Monolithic tempered glass on horizontal mullions with thermally-broken couplings.

- 6 Conventional curtain wall. Sealed glazing units with tempered glass.
- 7 Continuous vertical seismic separation joint with flexible rubber membrane, stainless steel plates anchored to structure and finishing aluminum sheet.

- 8 Conventional curtain wall with low-iron tempered double glazing.
- 9 Curtain wall support - Horizontal steel members anchored to historic stone wall and interior steel column.

- 10 Bent aluminium sheet assembly - cavity filled with insulation. Sealing curtain wall against historic stone wall.
- 11 Continuous 3mm folded aluminum sheet at floor with concealed fire stop between horizontal mullion and concrete slab.

- 12 Horizontal skylight with steel substructure. Sealed glazing units laminated - tempered glass.
- 13 Historic building - Stone parapet angle.
