# Atrium Townhome

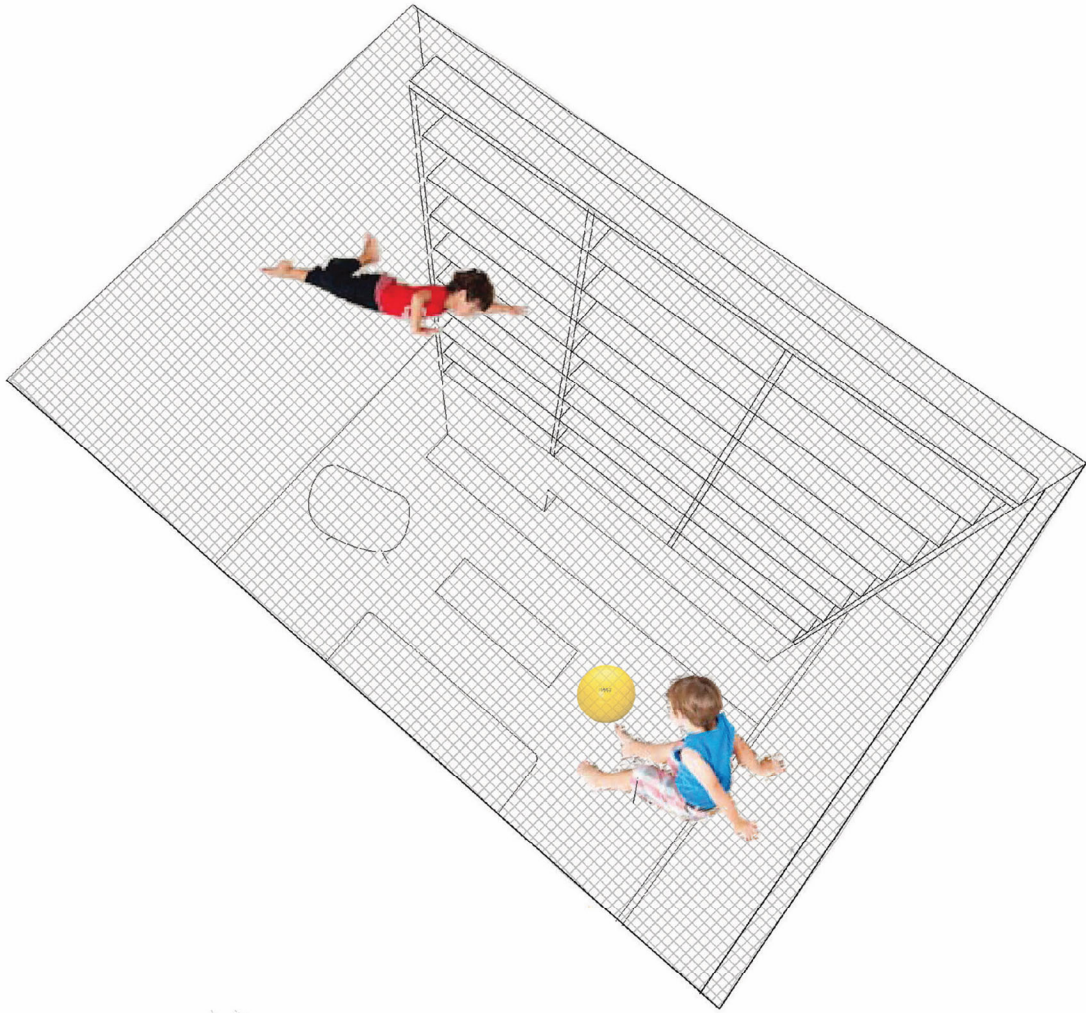
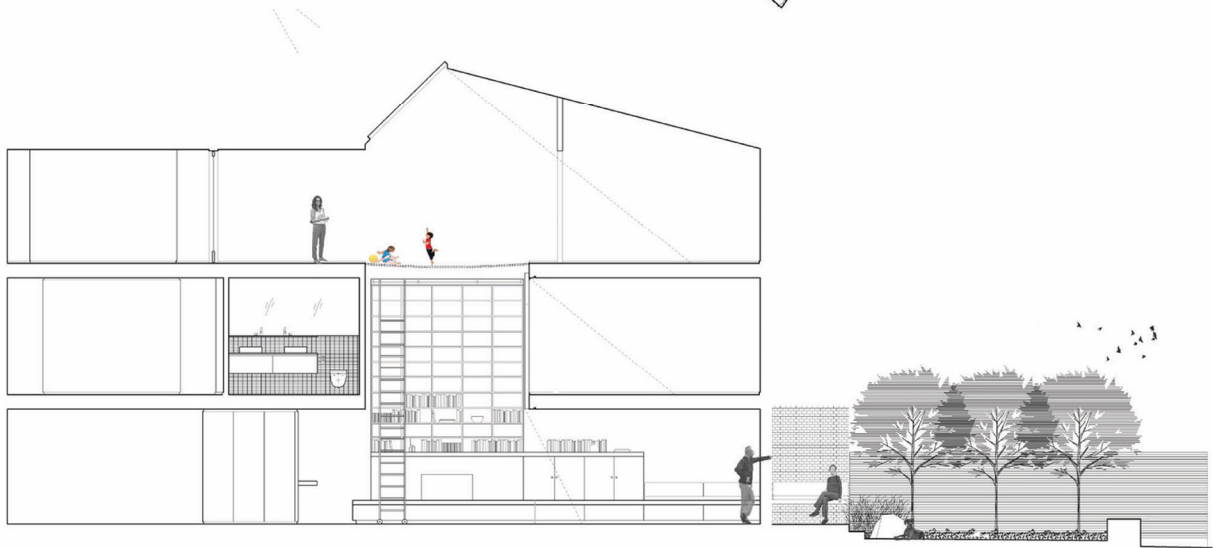
SECTION THROUGH THE STAIRS - DOUGLAS FIR WOOD SLATS

1. Entry
2. Douglas fir wood screen
3. Millwork "cube"
4. 3-storey douglas fir wood screen

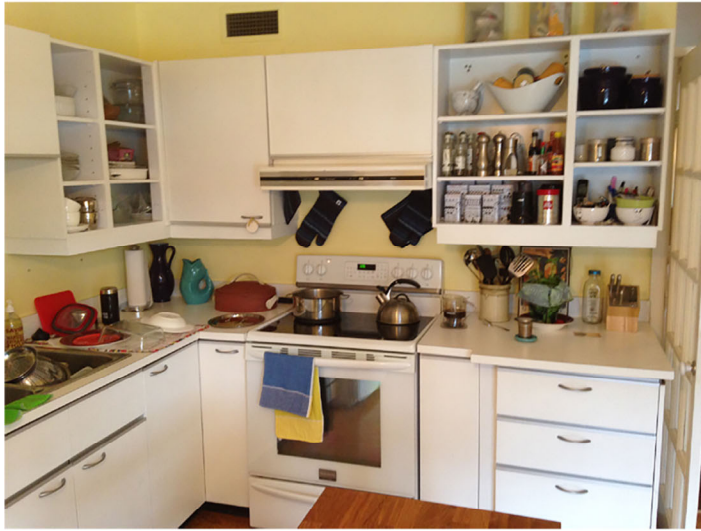
A view of kitchen before the renovations. The kitchen was relocated from the front of the home to the rear where it now enjoys a view of the south facing garden.

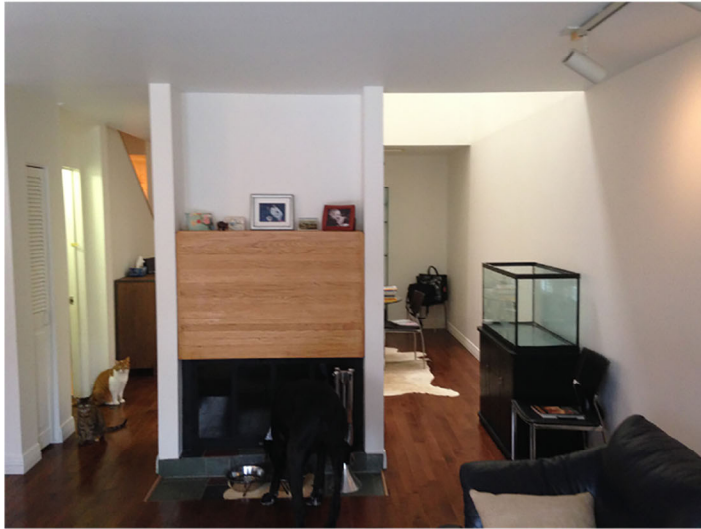
Prior to the renovations this old fireplace bifurcated the ground floor blocking views and making existing rooms feel small.

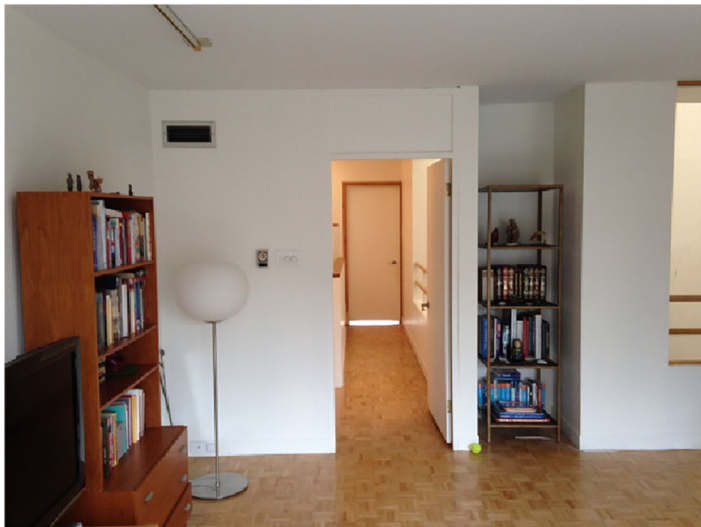
Old areas of parquet wood flooring were replaced with a combination of quarter sawn white oak and polished concrete floors.
