Hotel Room
Section C

Hotel Room
Section B

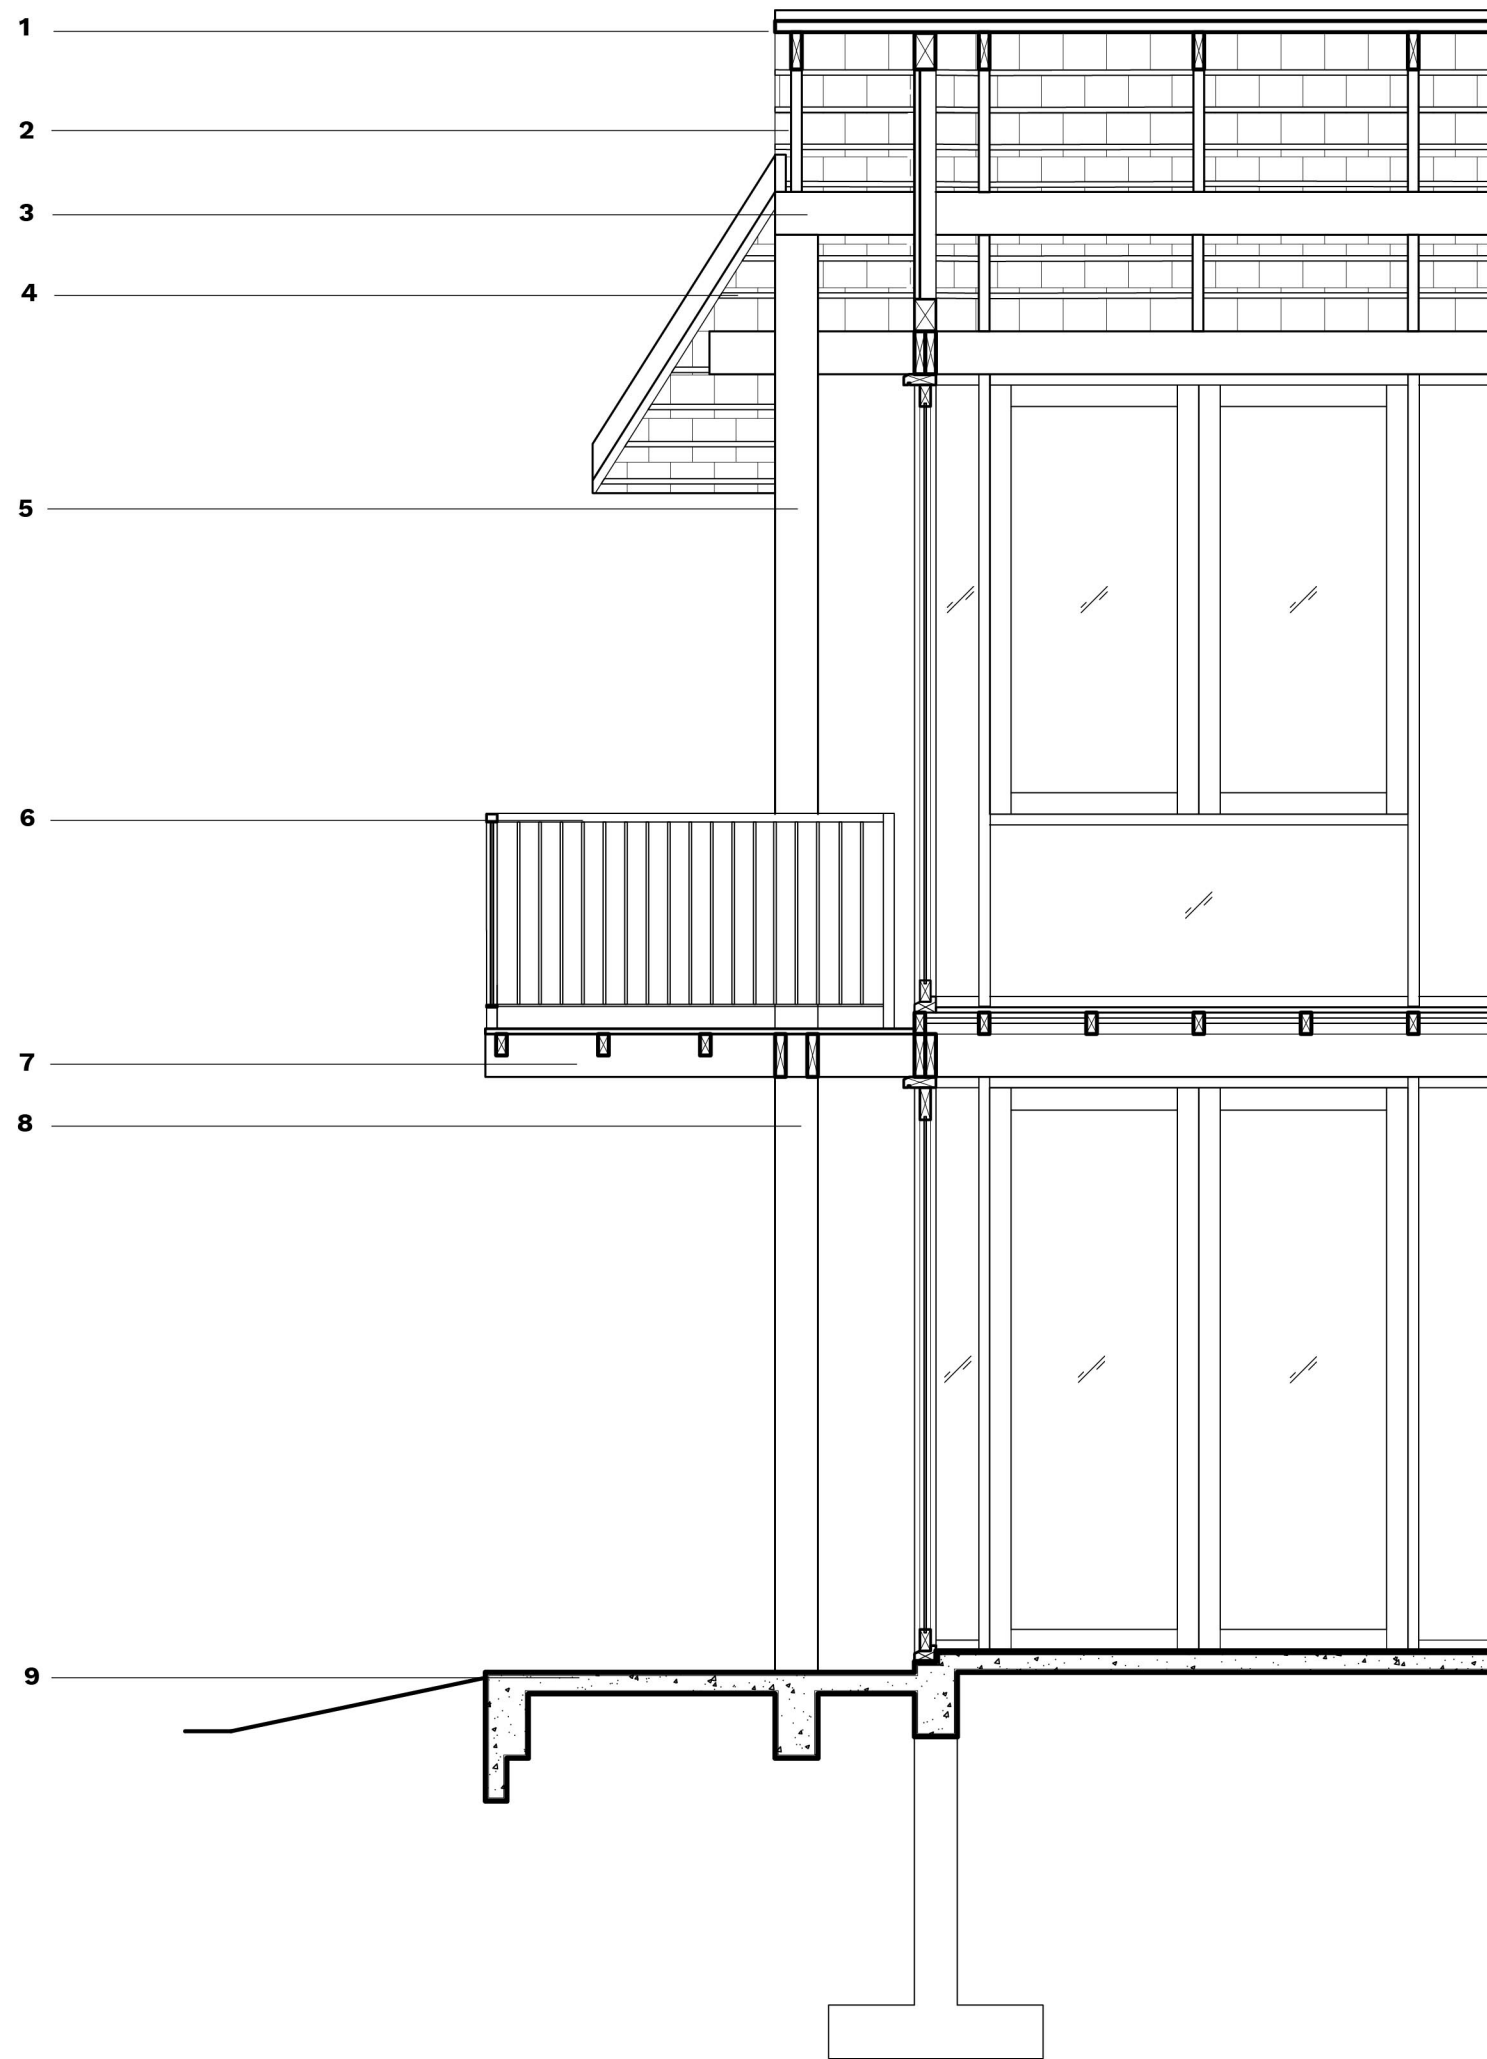
Hotel Room
Wall Section B

- 1 Wooden Shingles Roof
- 2 Timber Rafter
- 3 Timber Beam
- 4 Timber Purlin
- 5 Timber Column
- 6 Timber Railing
- 7 Timber Beam
- 8 Timber Column
- 9 Reinforced Concrete Floor
